Report

Serious incident on **16 August 2008**
on **take-off from Paris Charles de Gaulle Airport (95)**
to the **Boeing 737-800**
registered **SU-BPZ**
operated by **AMC Airlines**

BEA

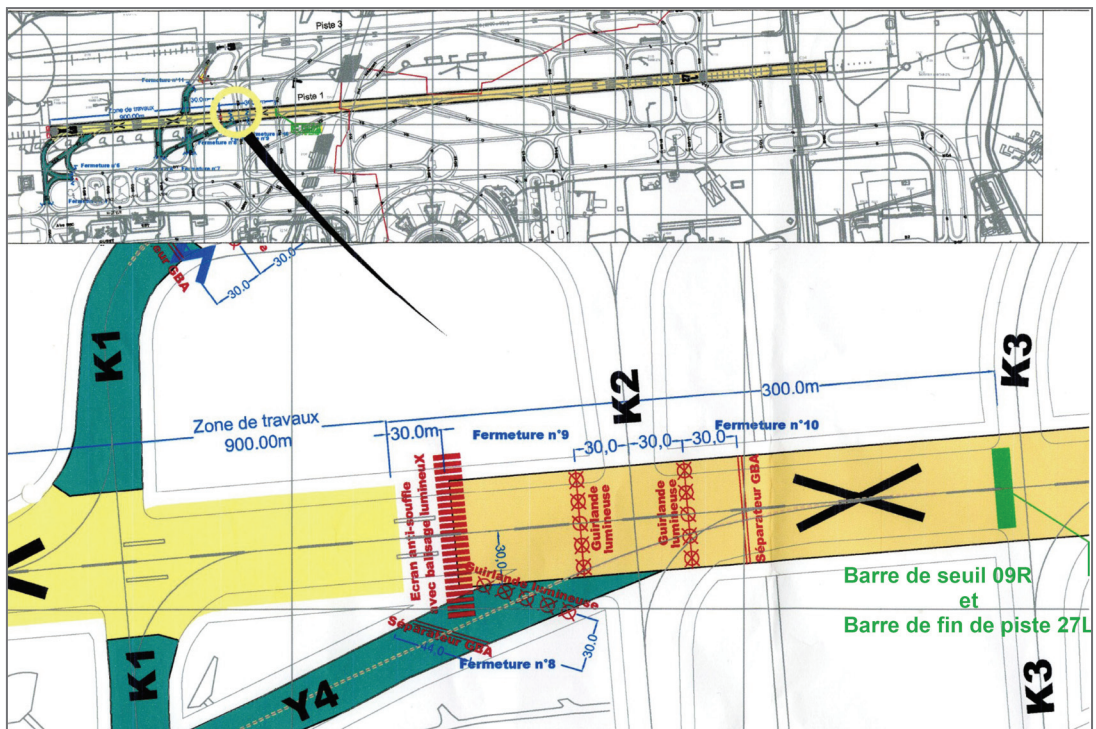
Plan by ADP for the taxi and runway closures

The two plans that follow were supplied by ADP. On the first, the workers' traffic zone, 36 m wide, arranged between the extended RESA and the works zone, is incorrectly positioned.

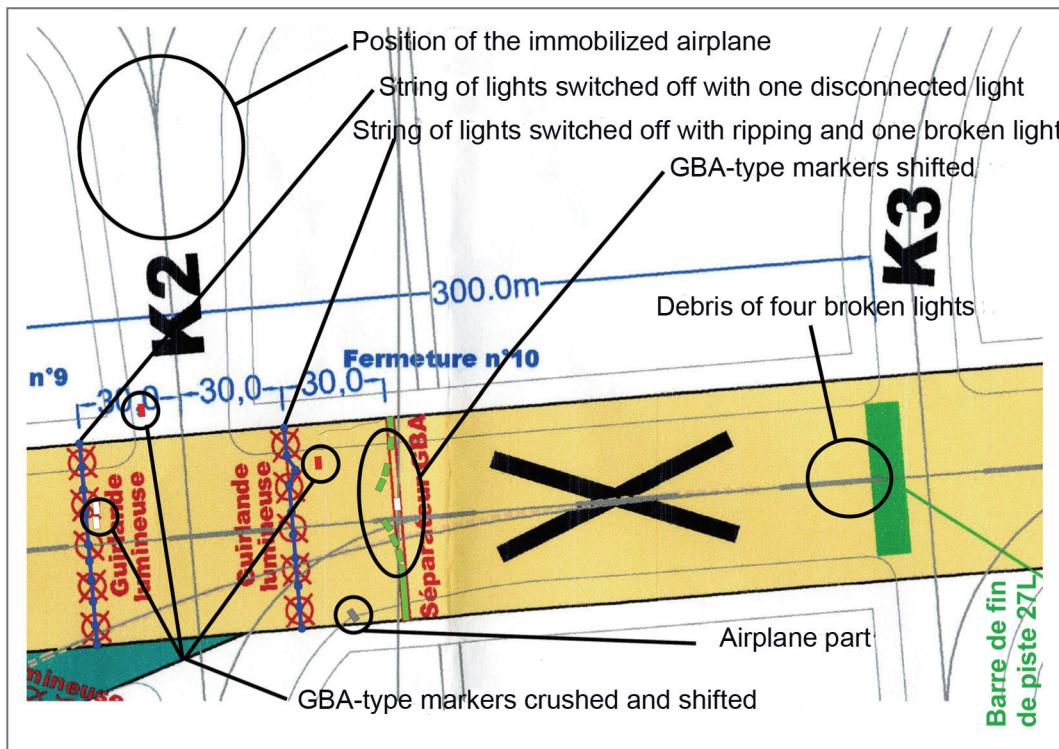
Two PCR coordinators visited the site at 02 h 37 on the 17 August, in order to clear the debris blocking track K2. ATC had been informed by flight BIE250 which should have used this taxiway (see diagram below).

The agents found two crushed white-coloured GBA's in the runway centreline on track K2 next to the lights situated furthest west. Switched off, it had not been displaced and a light had been disconnected without any sign of impact. A third GBA, crushed and red in colour, was on the North side of track K2 and to the South of the stop barrier, in front of any crossing airplane.

Once track K2 had been cleared, the agents visited the unusable part of the runway. On the other lights, also switched off, they reported that one light had been displaced towards the east and that another had been broken and violently torn out. They also found on the runway, to the North of the centreline, a fourth GBA, crushed and red-coloured as well as the left main landing gear harness support from SU-BPZ⁽¹²⁾ on the South boundary, two metres fifty from the lights. At the level of the GBA line, three markers had been displaced, on each side of a white marker situated near the centreline and which had not moved. The markers thus displaced formed a "funnel". Debris originating from the lights positioned at the end of the runway was found. It corresponded to the lights at the end of runway 27L nearest to the runway centreline and to the three 09R threshold lights situated closest to the centreline.

At 3 h 47 a team visited the site in order to replace the runway centreline end light and to line up the GBA's again. They left a space equivalent to two GBA's on either sides of the white marker that had not moved (this marker stayed positioned 0.45 m from the runway centreline). Two runway end lights situated on the far left that had not been working on the night of 16 August 2008 were also replaced.

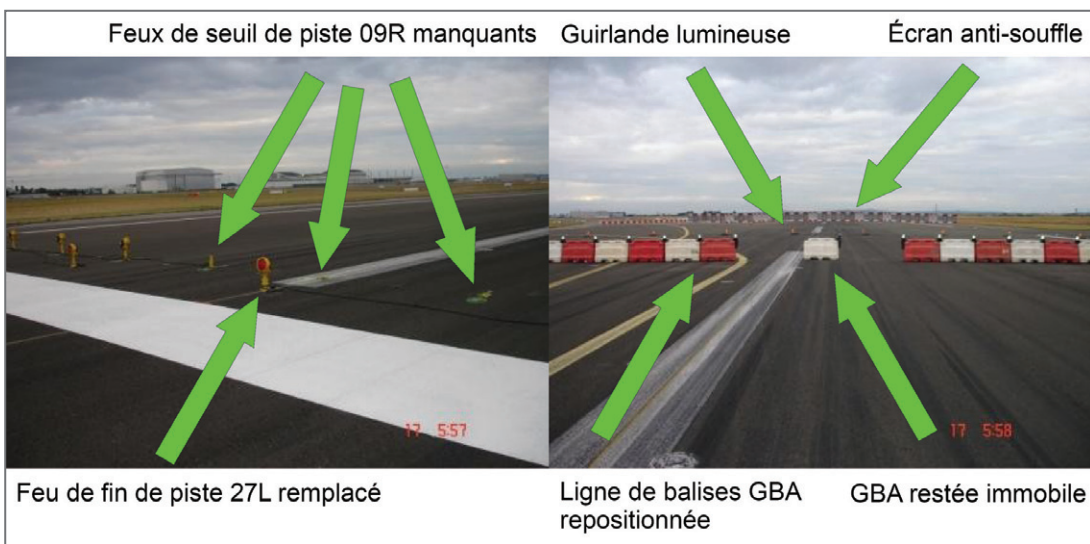
N.B: These photographs were taken some days after the event.

The central lights were damaged by a nose landing gear. AMC indicated that the only damage observed on the airplanes having served Paris Charles de Gaulle on 16 August, was that to SU-BPZ, including a cut on one of the nose landing gear tyres. Examination of the debris showed that the first impact on these lights was violent and of the kind to damage a tyre. It is thus likely that SU-BPZ destroyed the central lights and then that the debris, small in size, was dispersed, one of the main landing gears then running over it.

The left main landing gear harness support on SU-BPZ was damaged before the airplane's impact with a GBA. Observations on this part and on the lights allow the conclusion that SU-BPZ struck the runway end light to the left of the centreline; this would also explain, given the position of the airplane at impact, the damage on the threshold light situated to the right of the centreline. However, it cannot be ruled out from these observations alone that this last light was damaged previously, during flight AMV6404's takeoff.
